Manhole Inspection Summary

Manhole # S35G__067MH

Insp Date: **8/12/08 2:28 PM**

Location Address: **131 e redwood st**

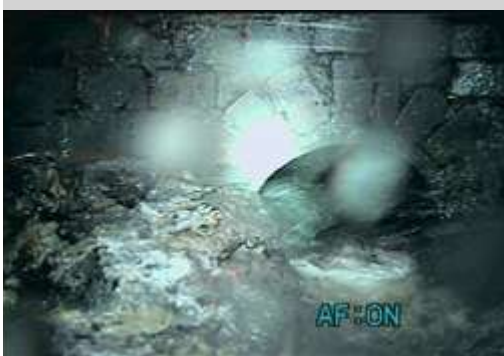
Defect 5

Condition: ☐ Sound ☐ Cracked ☐ Root Intrusion ☐ Deteriorated ☐ Leaks ☒ **Debris**

bench debris

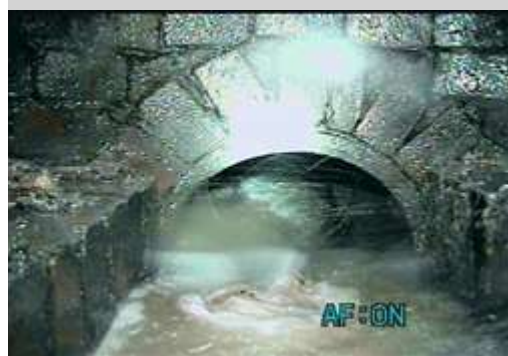
Defect 4

Condition: ☐ Sound ☐ Cracked ☐ Root Intrusion ☐ Deteriorated ☐ Leaks ☒ **Debris**

channel debris

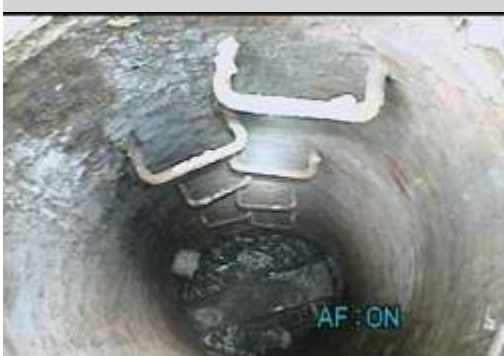
Defect 3

Count: **10** Missing: **0** ☒ **Corroded**

steps

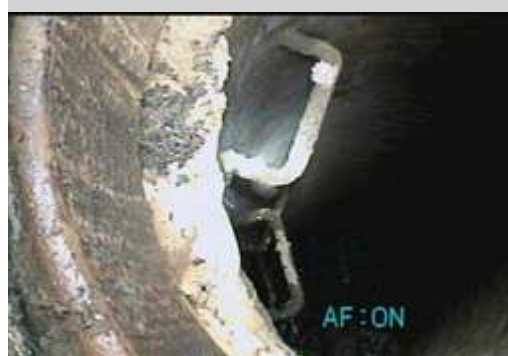
Defect 2

Offset: **2** (in.)

offset

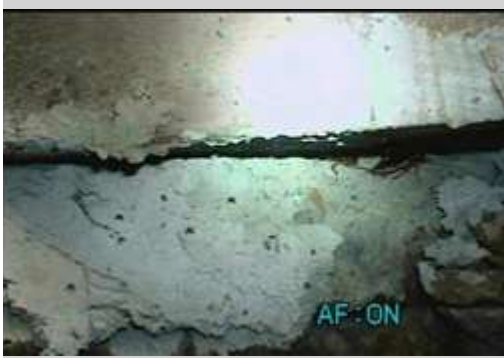
Defect 1

Condition: ☐ Sound ☐ Cracked ☐ Root Intrusion ☐ Loose Brick ☒ **Deteriorated**

chimney deteriorated, frame adj

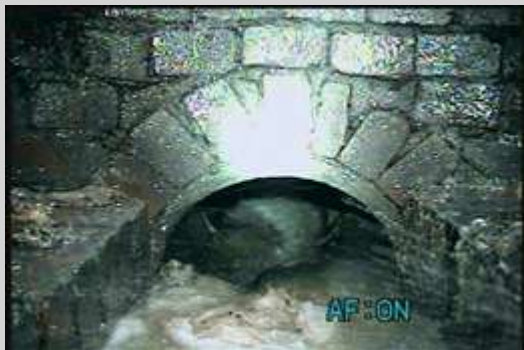
12 O'Clock Outflow

12 in. Circular Gravity Sewer
Pipe Out @ 12 O'Clock

Pipe Material: **Clay** ☐ Pipe Lined

Invert Depth: **16.33** (ft.) Flow Characteristics: **Fast**

Infiltration: **None** Pipe Seal Cond: **Unknown**

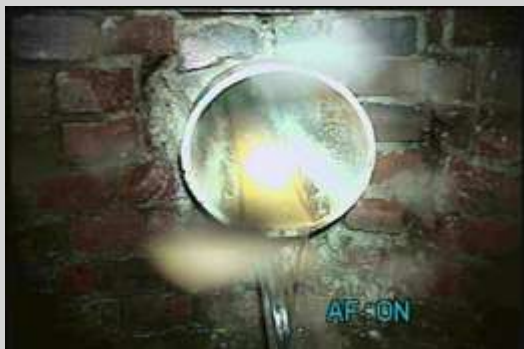
1 O'Clock Inflow

6 in. Circular Gravity Sewer
Pipe In @ 1 O'Clock

Pipe Material: **PVC** ☐ Pipe Lined

Invert Depth: **13.25** (ft.) Flow Characteristics: **Fast**

Infiltration: **None** Pipe Seal Cond: **Unknown**

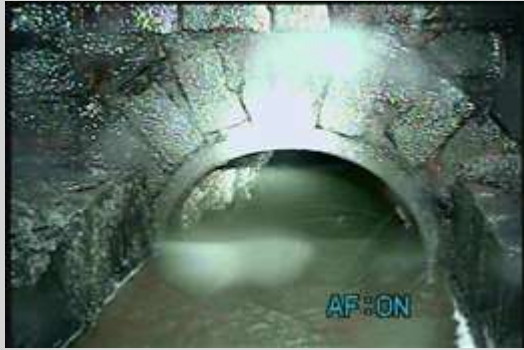
7 O'Clock Inflow

12 in. Circular Gravity Sewer

Pipe In @ 7 O'Clock

Pipe Material: **Clay** ☐ Pipe Lined

Invert Depth: **16.25** (ft.) Flow Characteristics: **Fast**

Infiltration: **None** Pipe Seal Cond: **Unknown**
